## 'TILLEGRA DAM - IS THE STORAGE SAFE?'

Mr G Holt, CPEng, CP(Geol) – February 2007

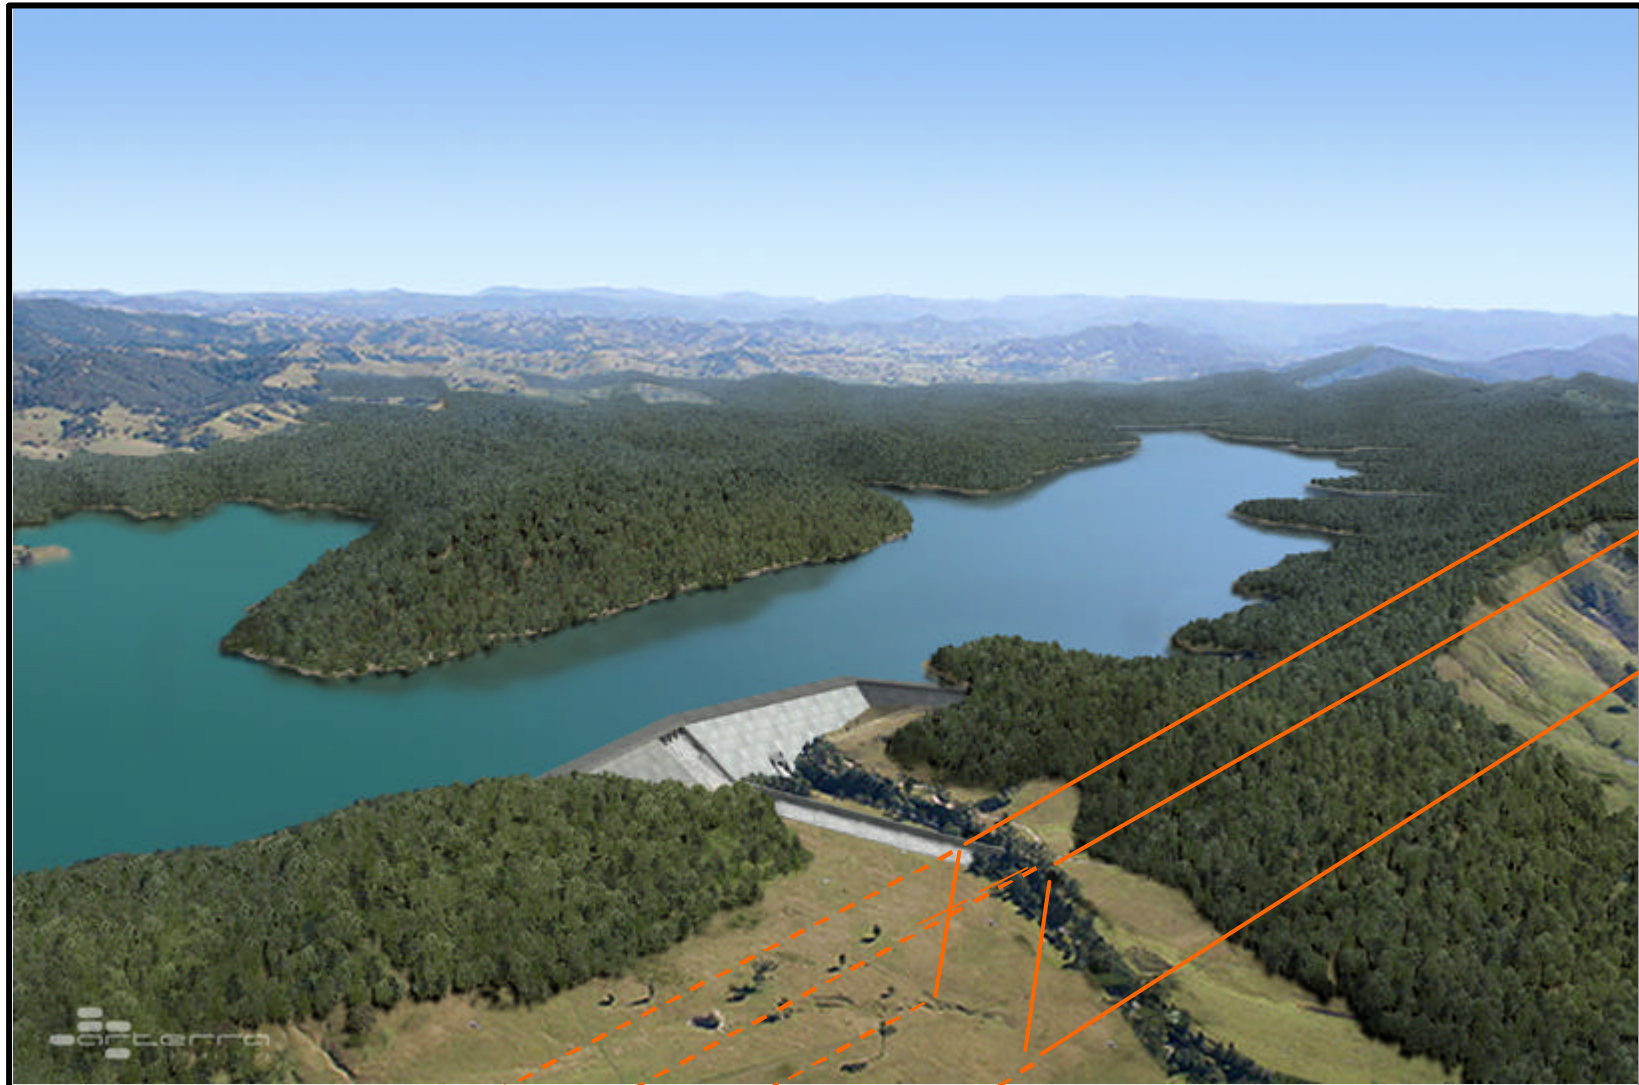
# “Tillegra Fault” Forms East Side Of Storage

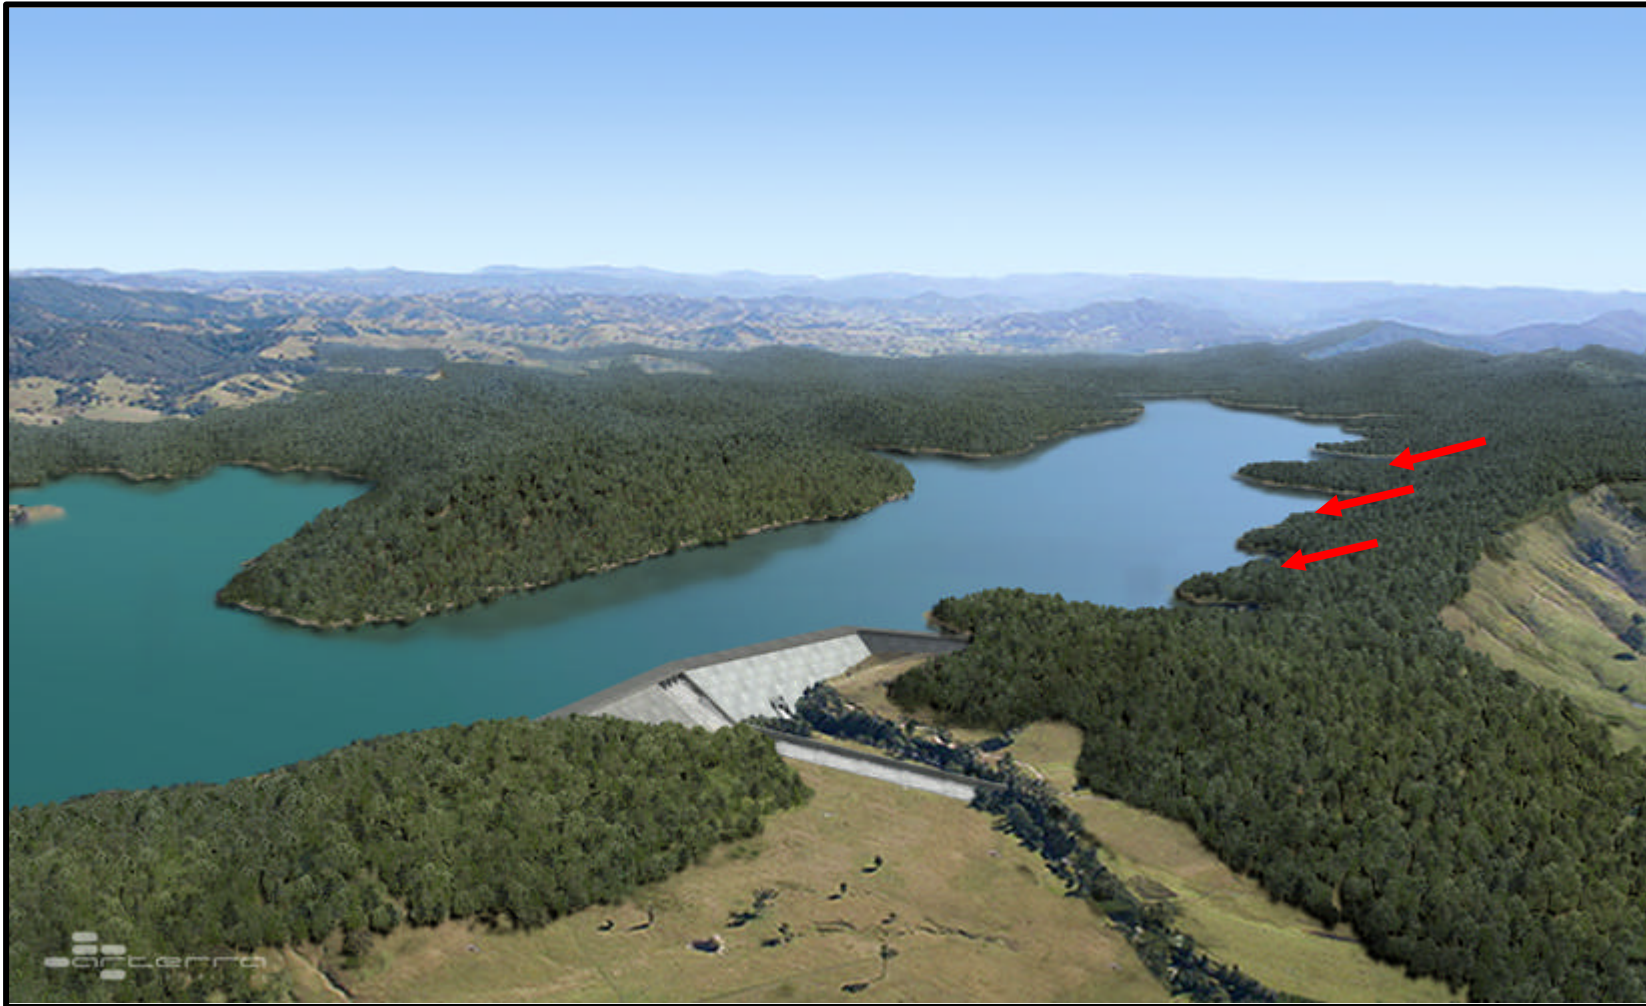
# Landslips Inside Storage Area Already Weaken Storage Rim

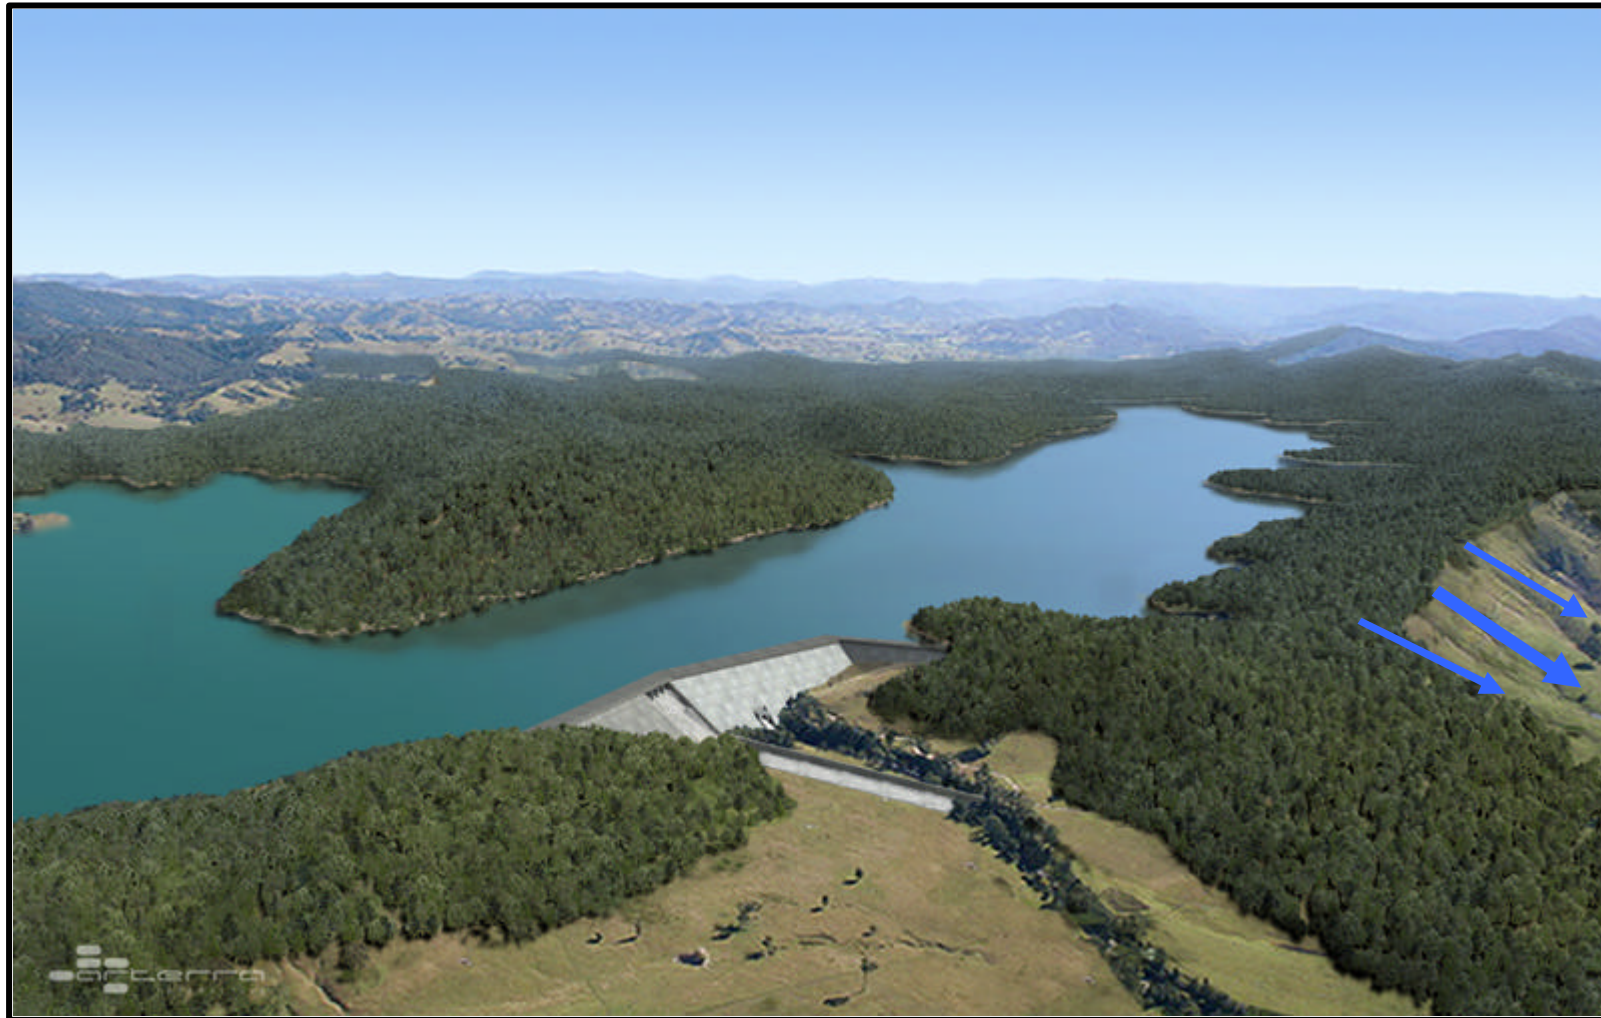
# Water Will Soak Through Fault

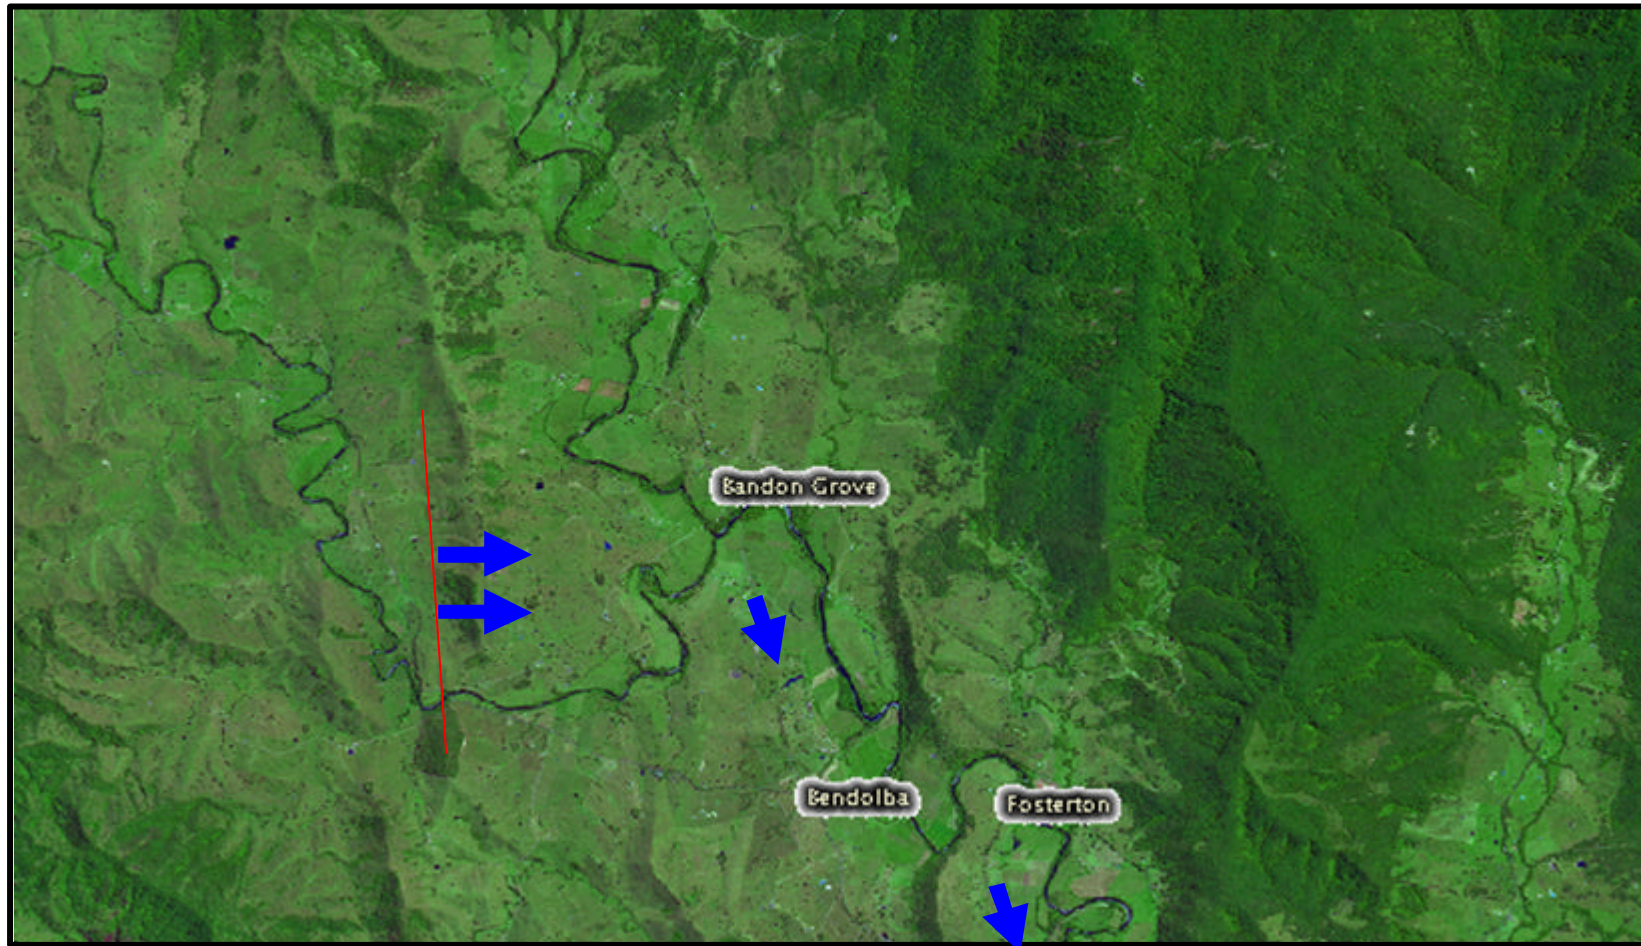
# Rim Collapses – Floods Williams River Valley Downstream
