'TILLEGRA DAM - IS THE STORAGE SAFE?'

Mr G Holt, CPEng, CP(Geol) – February 2007

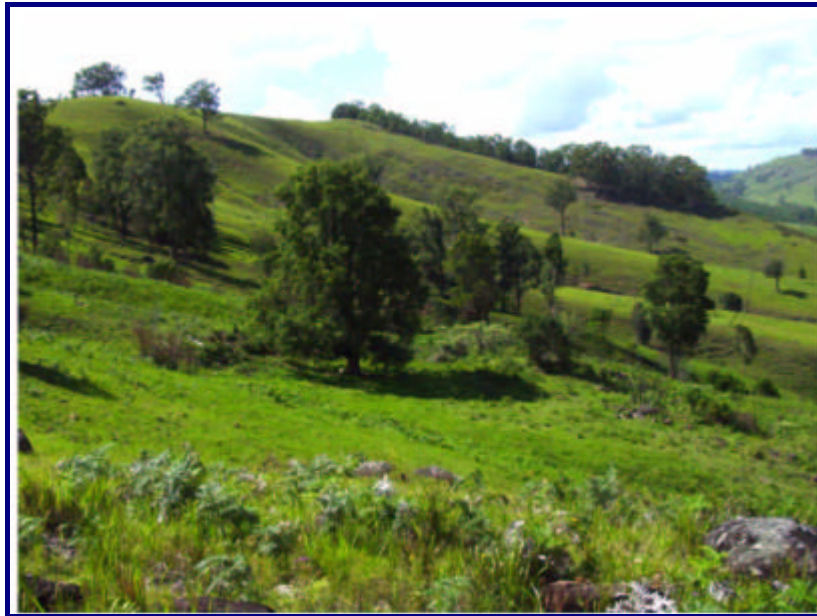
Landslips inside the rim of the proposed storage

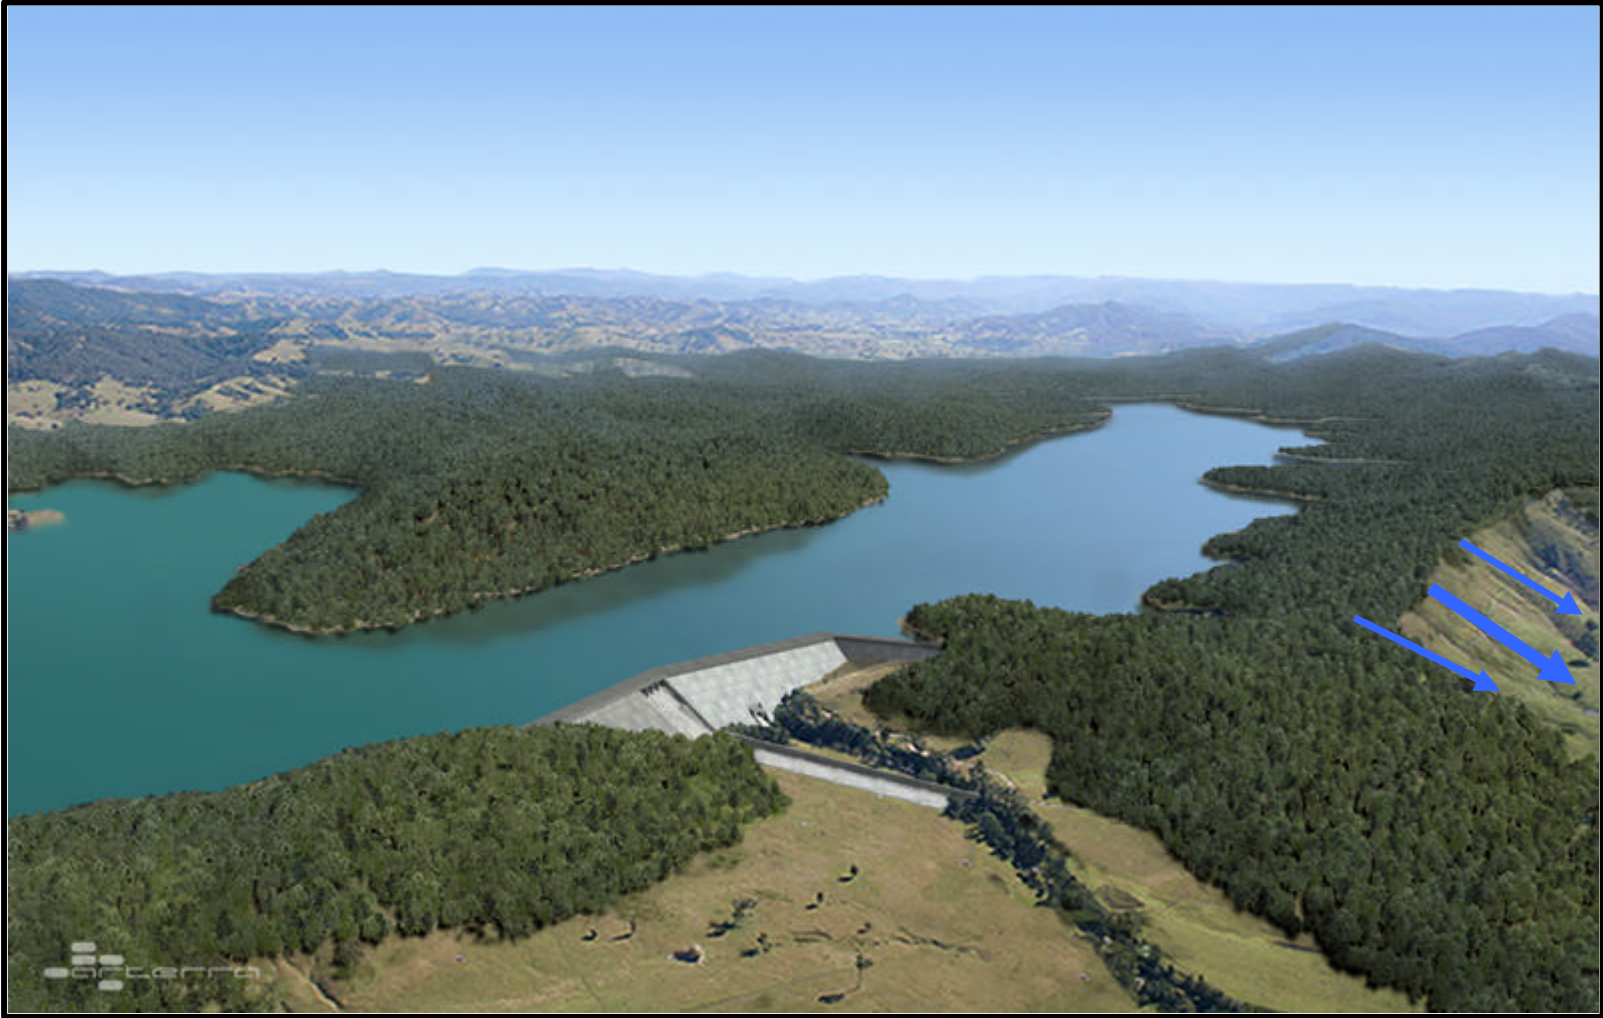
Water Will Soak Through Fault
